Portage Creek Sediment Remediation Project Kalamazoo, Michigan

Pre-Sediment Removal Structure Feature Assessment
Removal Areas SA5-Axtell, SA5-D and SA5-C

F&V Project Number: 809930
May, 2012

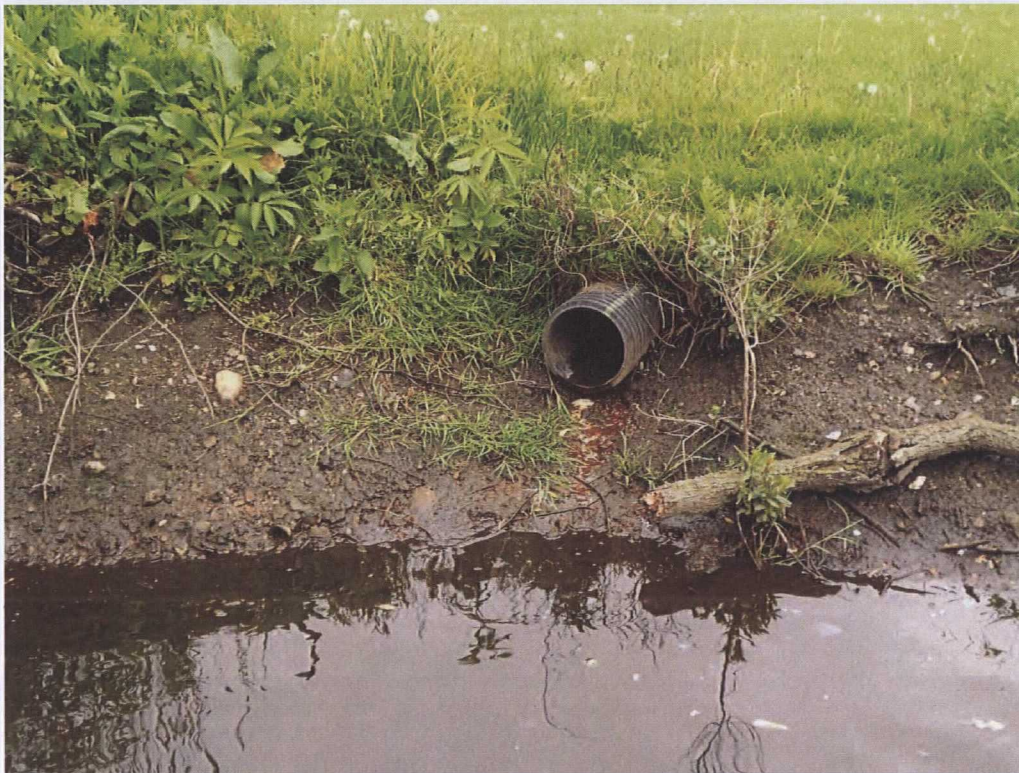
- Moderate bank erosion has exposed ~12-18" of the pipe, however, the pipe is set back approximately 2' from the water's edge in an area where the bank is low.
- The pipe appears to be in good condition with no significant deterioration noted.
- The outlet is slightly undermined.

View of the outlet from the channel

- Because the structure is set back from the water's edge, further undermining is not a significant concern. However, undermining should be repaired if it does occur.
- At the time of evaluation, the outlet had a small flow of water and an isolation cofferdam is recommended for dewatering.

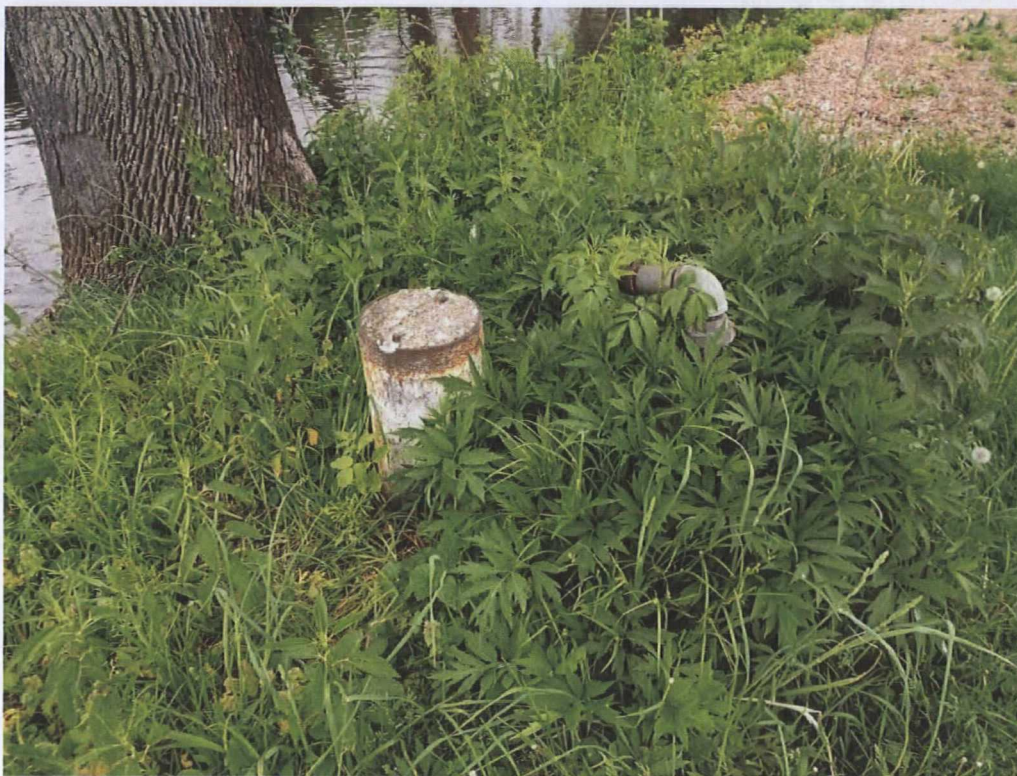
- Both bollards have minor surface corrosion and are overgrown with vegetation.
- The east bollard is set back approximately 4' from the water's edge behind a large tree. The west is located approximately 1' from the water's edge.

East bollard and suspected abandoned gas main

- The bollards and conduit should be protected from damage during excavation operations by installing construction fencing or other means to make operators and drivers aware of their location.
- The west bollard can likely be removed if it conflicts with excavation operations, however the east one should be avoided to prevent impacting the suspected abandoned gas main.

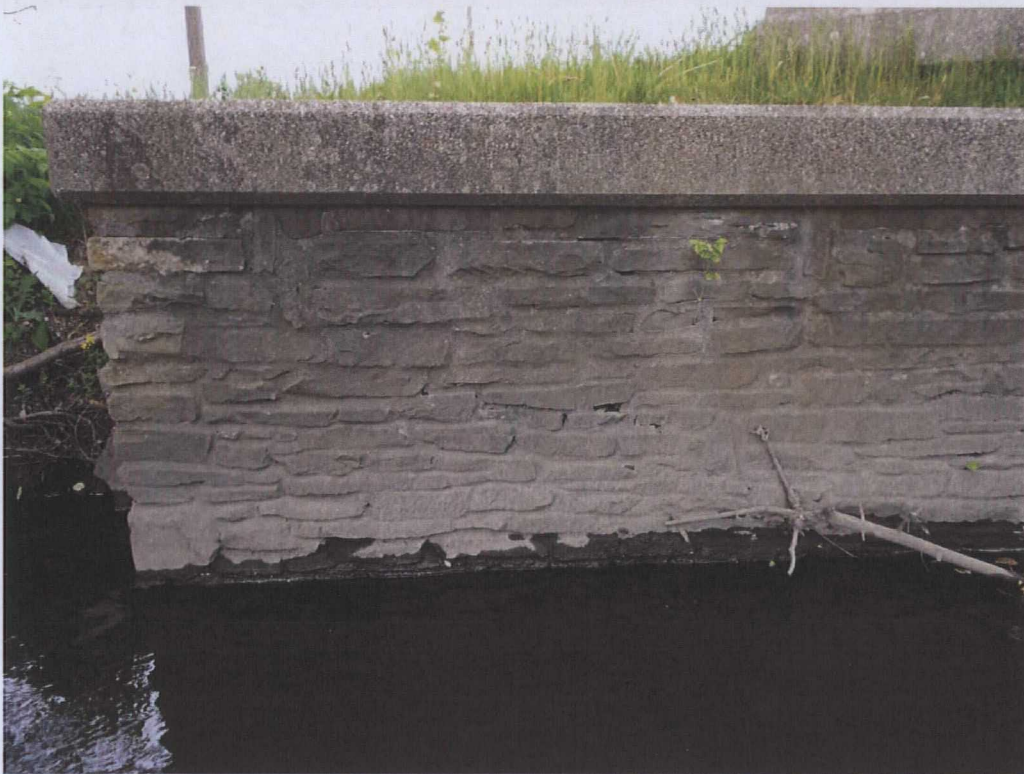
- Moderate erosion was noted behind the southwest wingwall with concrete rubble placed as riprap. Cracking and gaps were noted in the mortar joints.
- There is a significant amount of woody debris caught on the upstream face of the structure. The debris is reducing the flow in the west pipe, causing high velocities and deepened channel in the east pipe.

Cracking and gaps in mortar joints of southwest wingwall

- The wingwalls and headwalls are masonry-type construction with various degrees of cracking and are more susceptible to damage from vibration than concrete. Therefore it is recommended that the cofferdams at the Crosstown Parkway bridge be constructed of sand bag walls, placed with approximately 4' clearance from the walls.
- The unidentified steel cover in the northwest should be excavated and opened prior to cofferdam installation to check for a possible utility crossing.

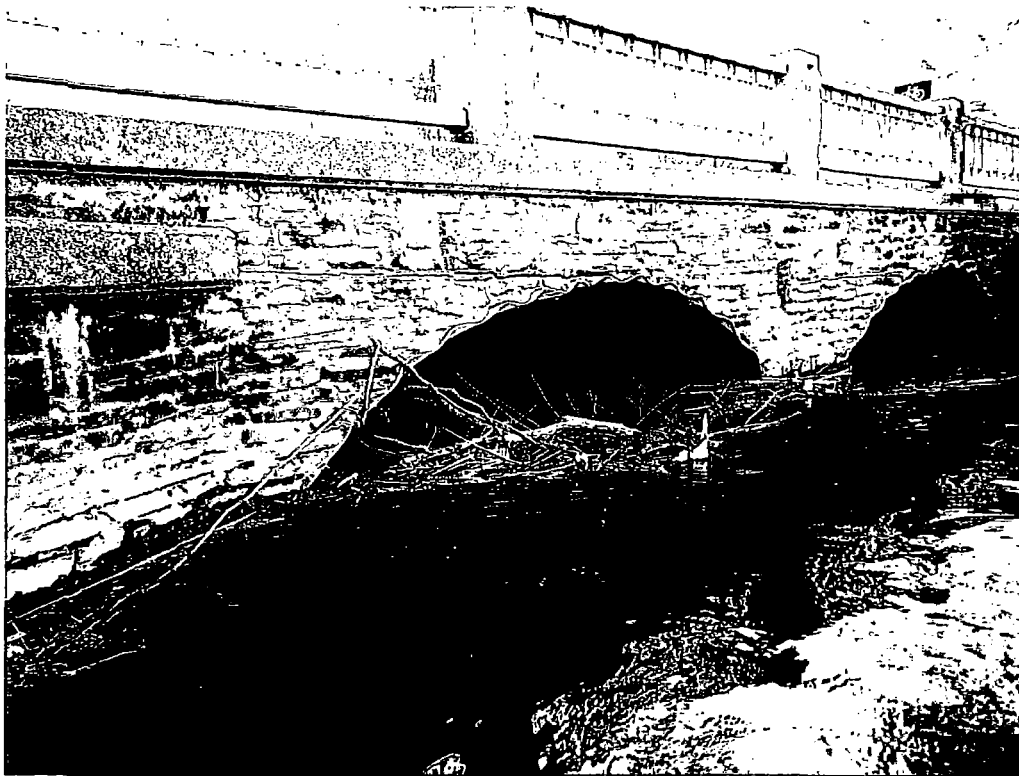
Woody debris caught on upstream face of structure

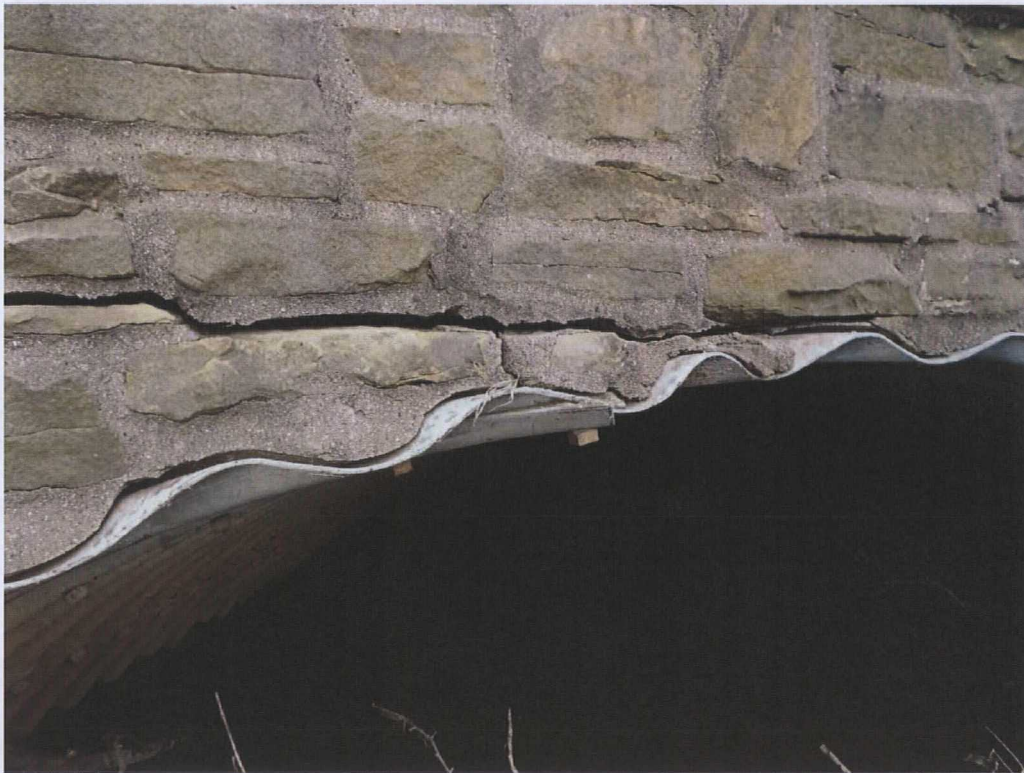
- There is severe horizontal cracking in the south headwall, approximately ½" wide from the high point of both culverts heading west. Scattered vertical cracking was noted as well.

Close-up of cracking in southeast headwall

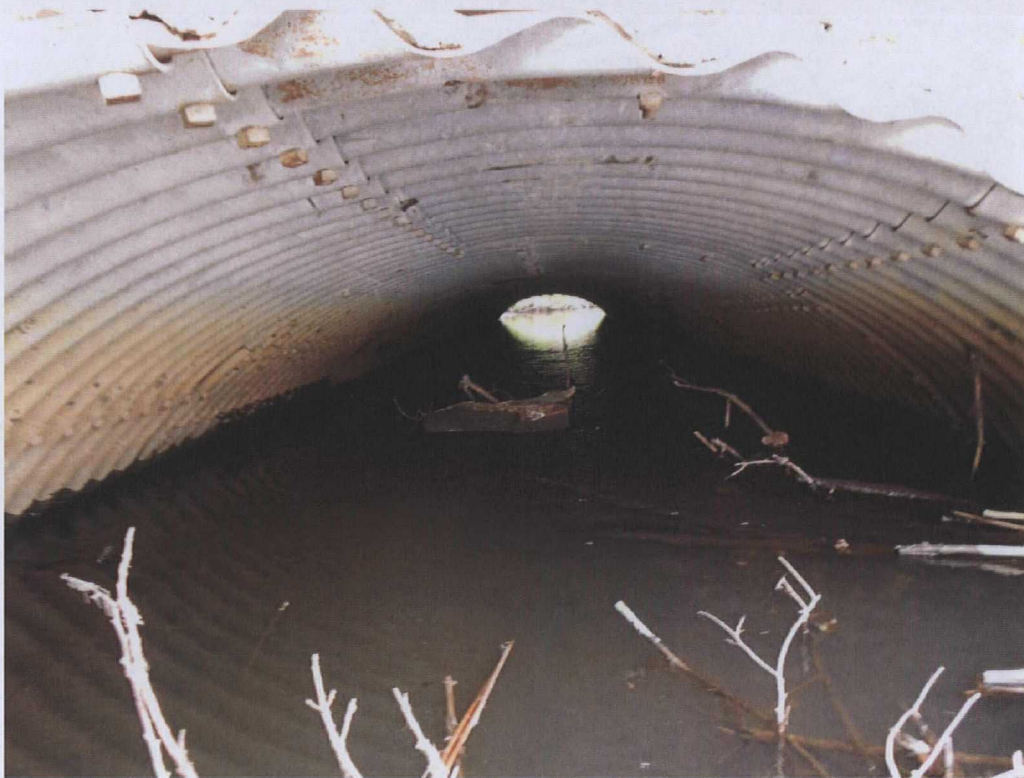
- Minor sagging was noted in the culvert pipes below the roadway. Minor corrosion was noted at the joints between plates, severe in spots.
- The surface is newer asphalt, concrete curb and gutter. There are newer concrete sidewalks between the curbs and headwalls.

Minor sagging of culvert under roadway

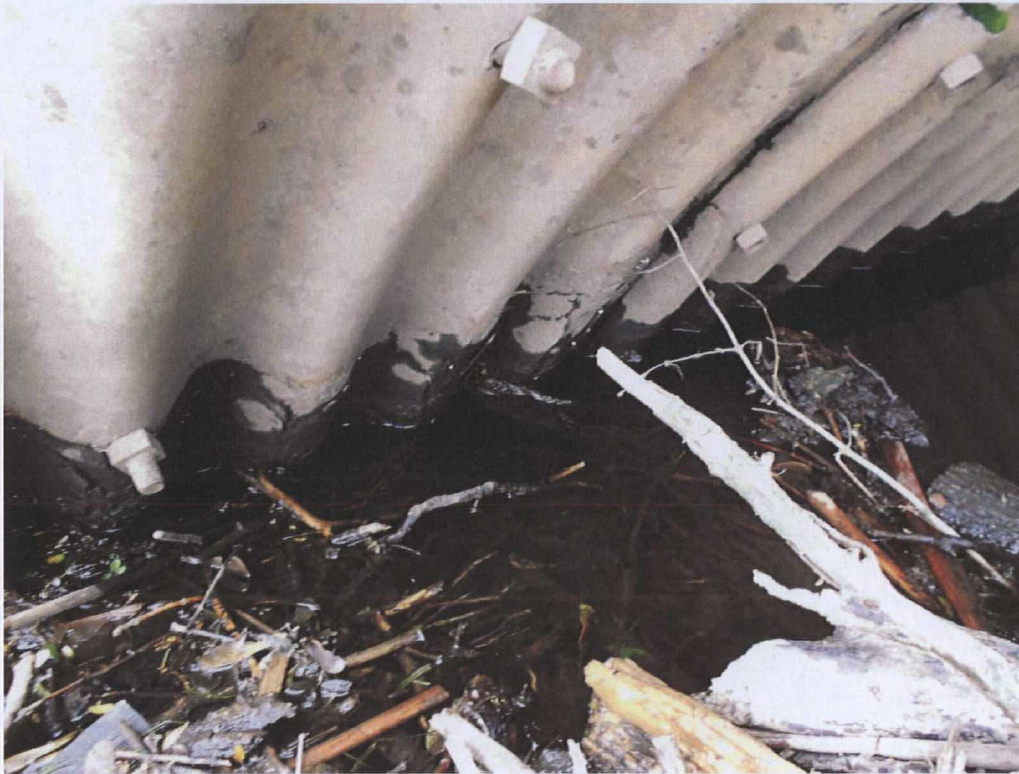
- Minor surface corrosion was noted on the culverts above the waterline and moderate to severe corrosion with scaling at the waterline.
- There is a large tree growing at the end of the southeast wingwall. The southeast wingwall has minor gaps and cracks in the mortar joints. There is a large sinkhole behind the wall filled with concrete rubble.

Corrosion and scaling of steel plate along waterline

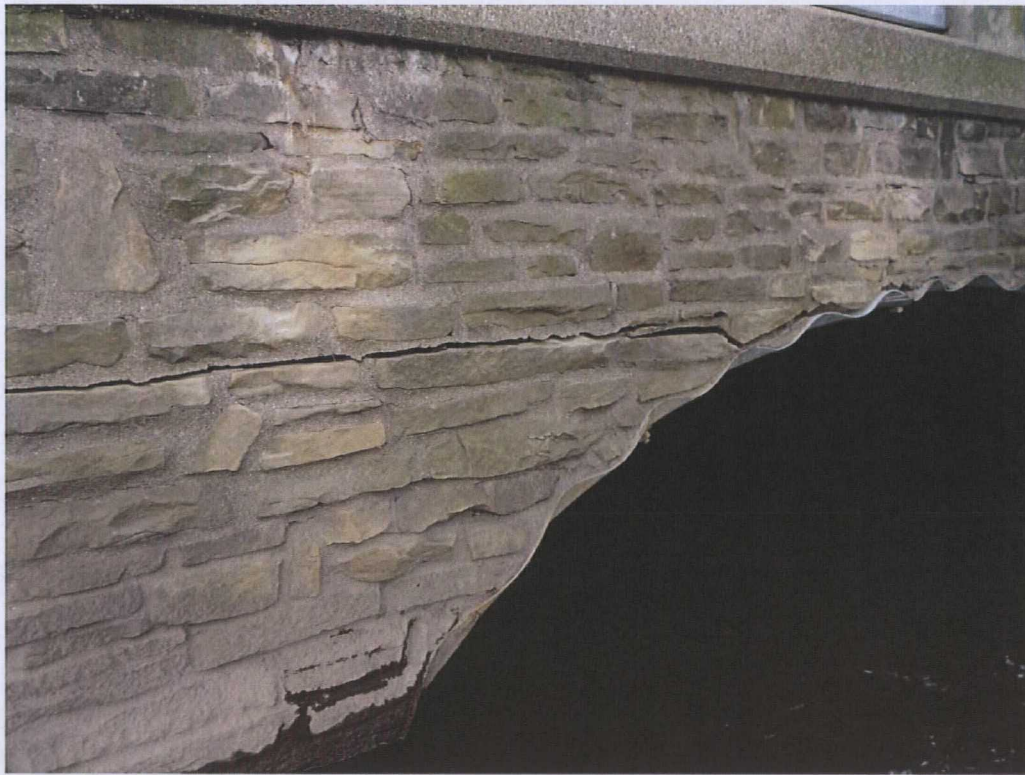
Horizontal cracking in southeast headwall

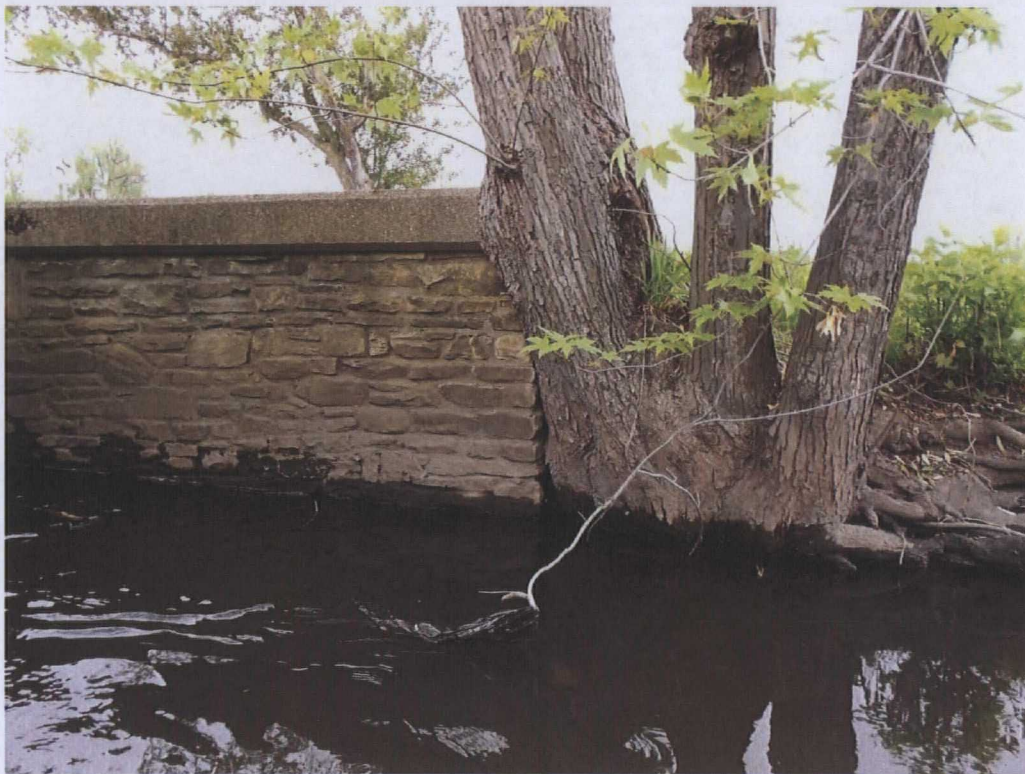
Tree growth at end of southeast wingwall

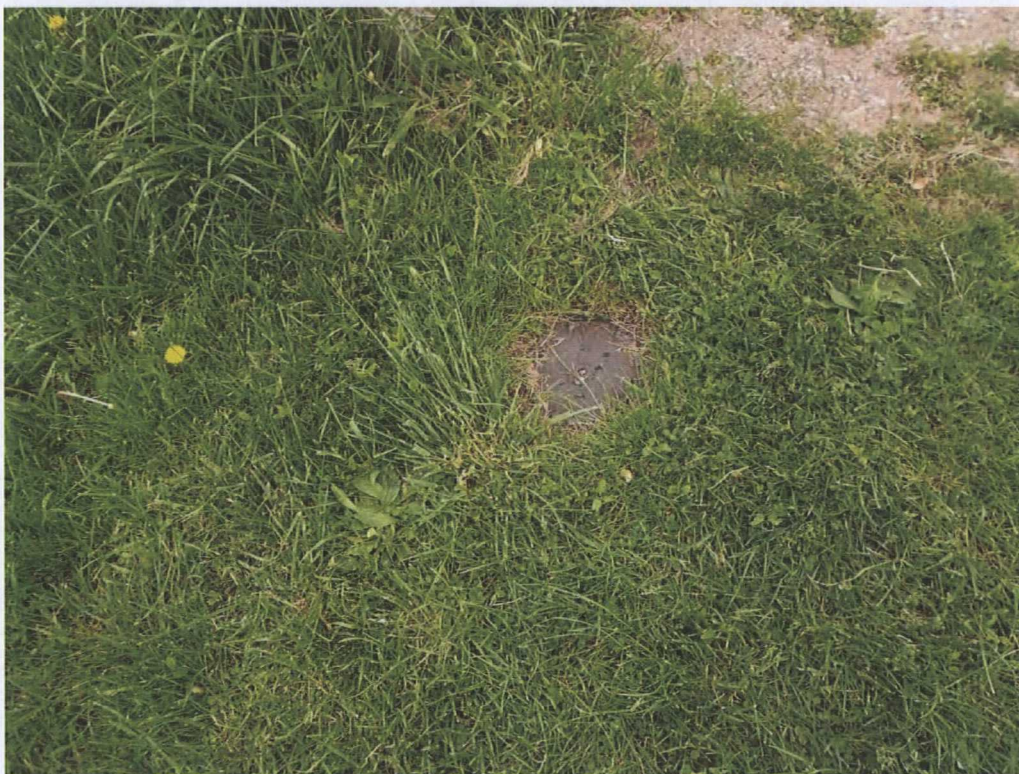
- There is an unidentified steel cover in the northwest and an abandoned conduit on the north headwall.
- Severe erosion was noted around the northwest wingwall with failed concrete rubble placed as riprap. Minor gaps and cracks were noted in the mortar joints.

Unidentified steel cover in northwest

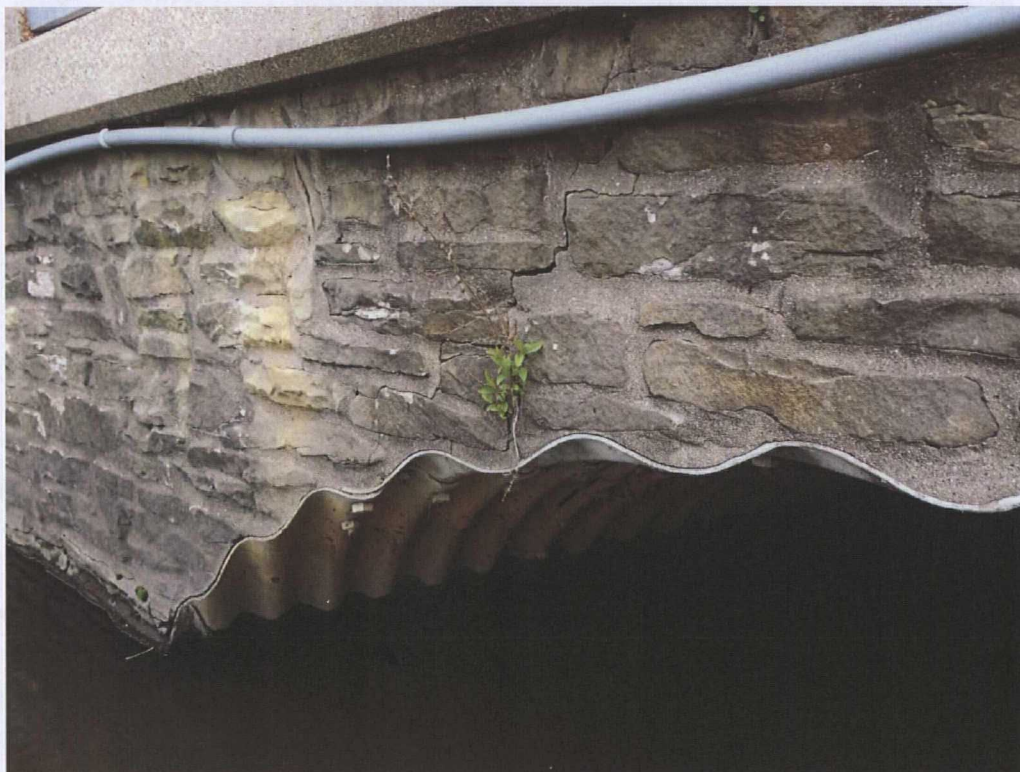
- The north headwall has moderate to severe step cracking in the northwest with vegetation and severe horizontal / step cracking in the northeast up to ½" wide.

Step cracking in northwest headwall

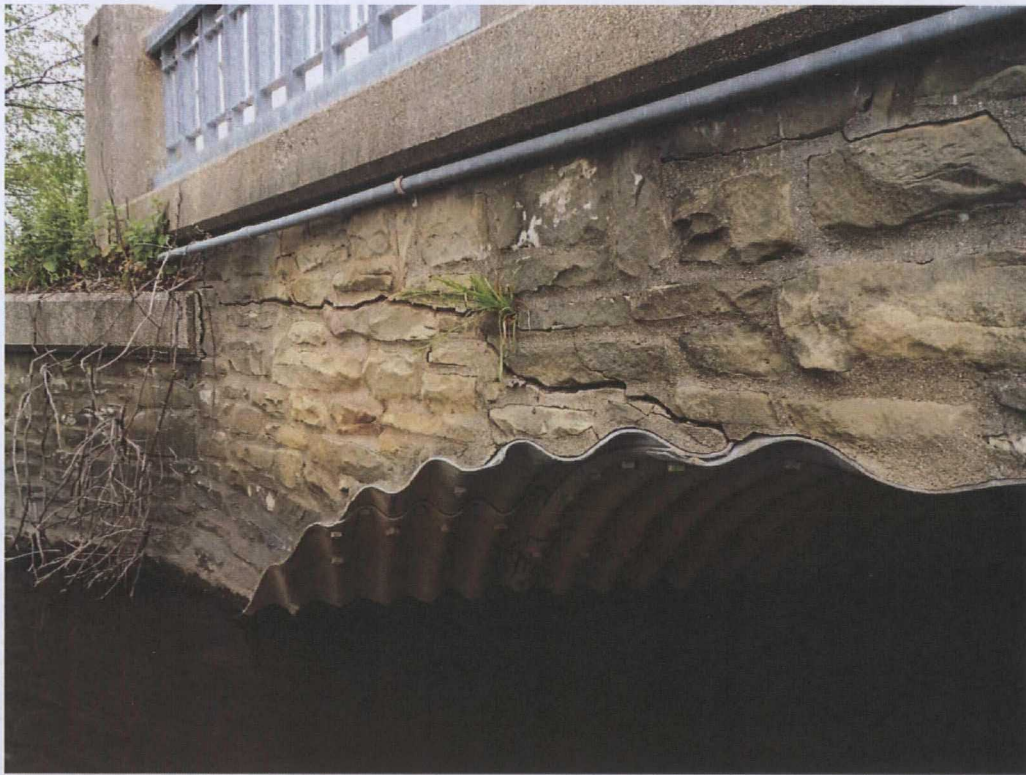
Horizontal and step cracking in northeast headwall

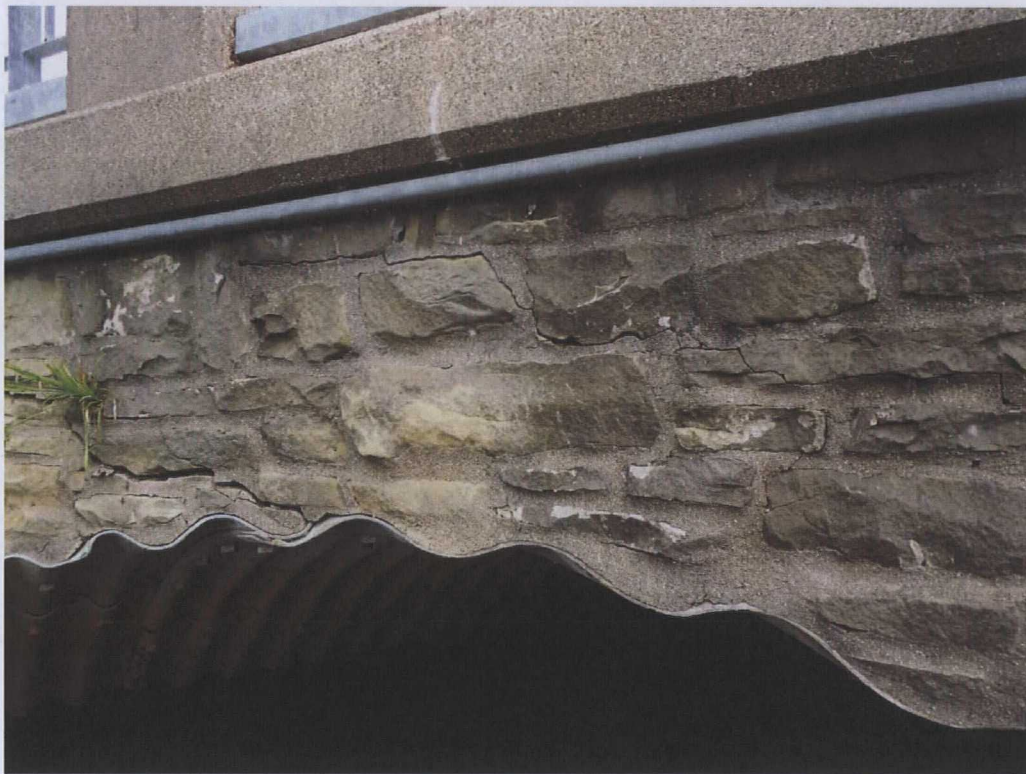
Step cracking in northeast headwall

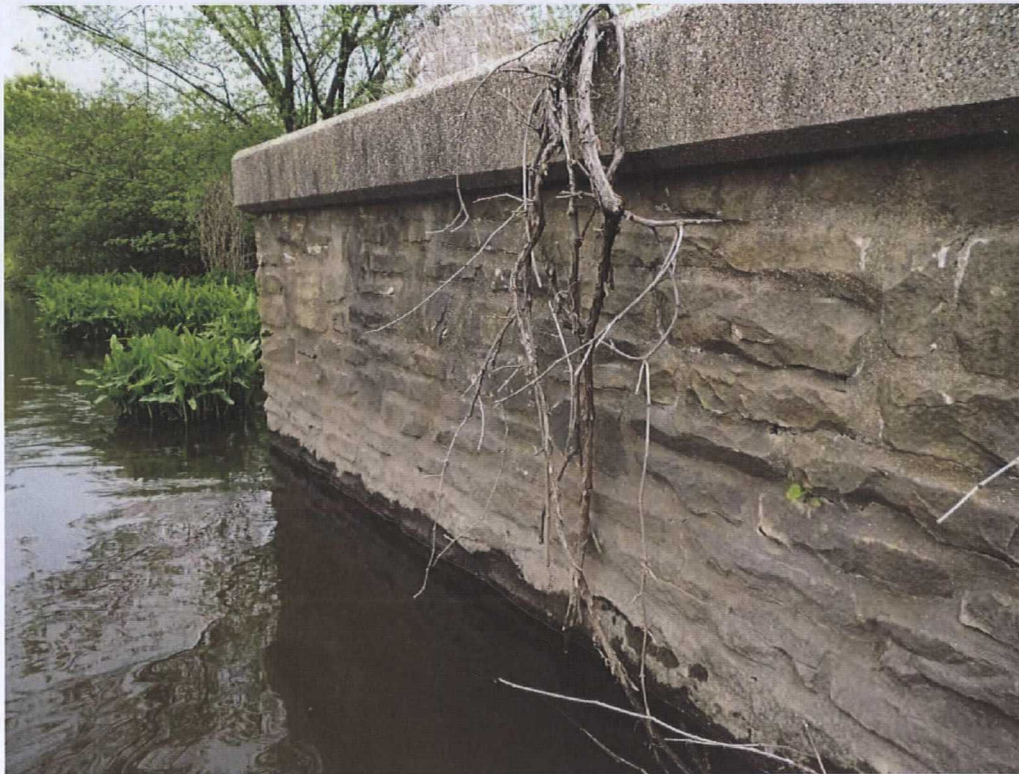
- The channel has deepened in the northeast however no footing was detected.
- Minor gaps and cracks were noted in the northeast wingwall mortar joints. The wall is overgrown with vines. Moderate erosion was noted behind the wall.

Vine growth on northeast wingwall

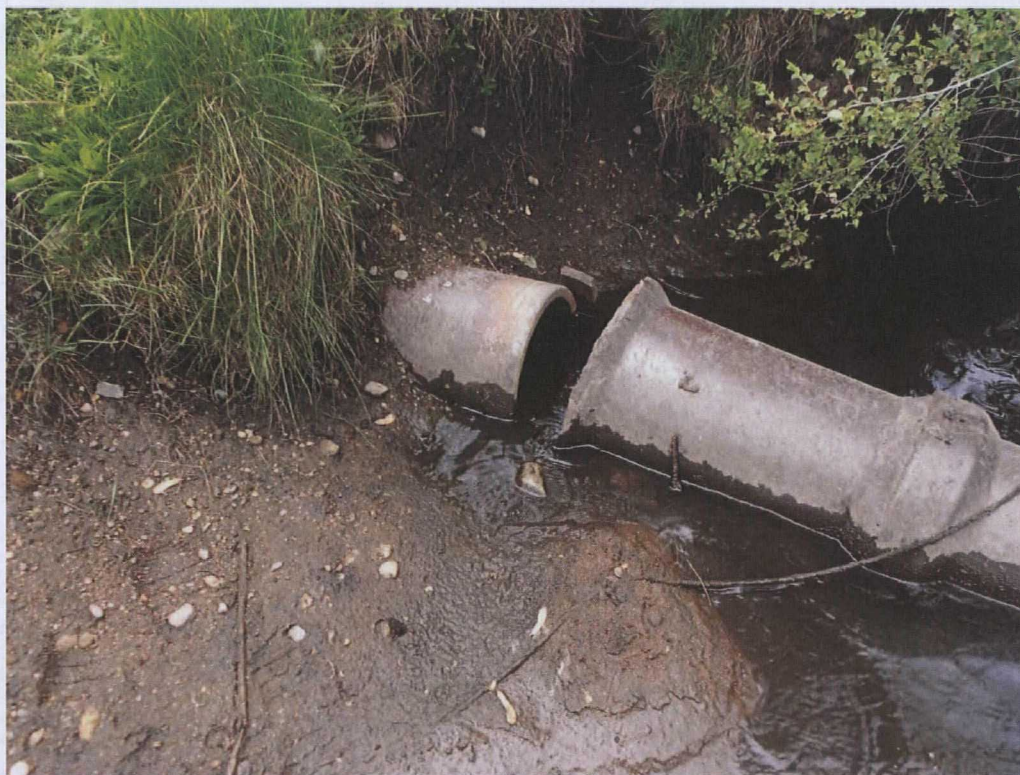
- There are 3 failed sections (~6') in the channel and the 4th exposed approximately 12" from severe bank erosion.

Cracked bell at failed section

- Remove the 3 failed sections. Protect the outlet with an isolation cofferdam to allow for dewatering.

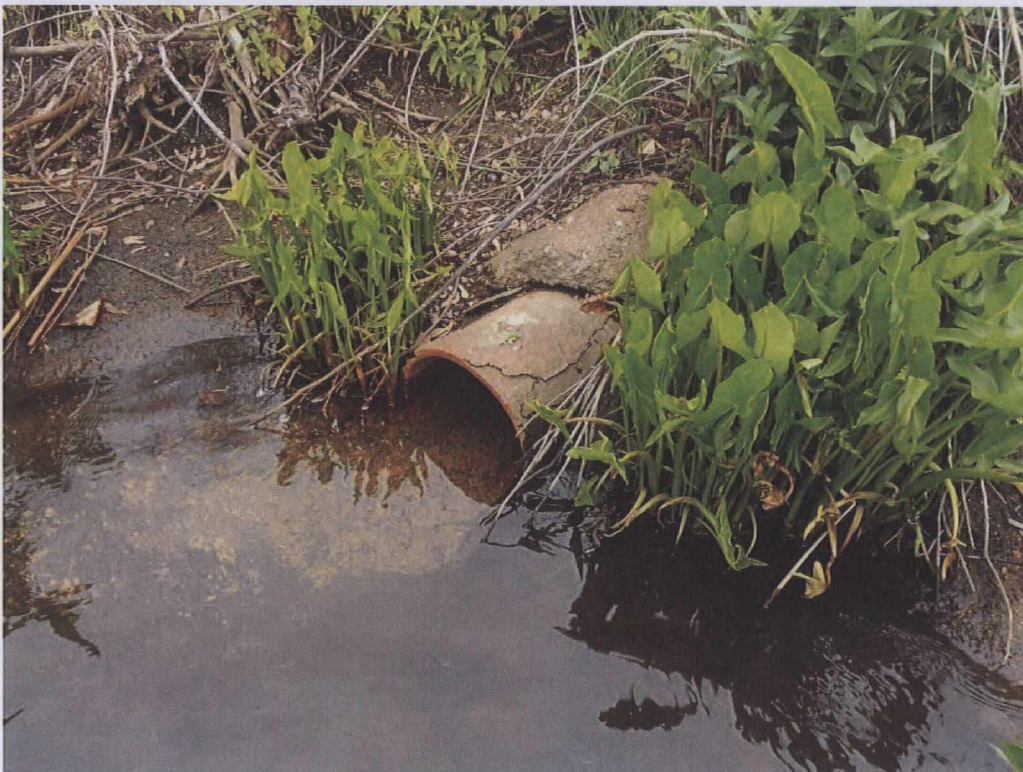
- The end of the pipe is exposed ~12" from bank erosion in the area. It is severely cracked and scaled.
- The concrete collar around the pipe is severely spalled.

Cracking and scaling of end section and spalled concrete collar

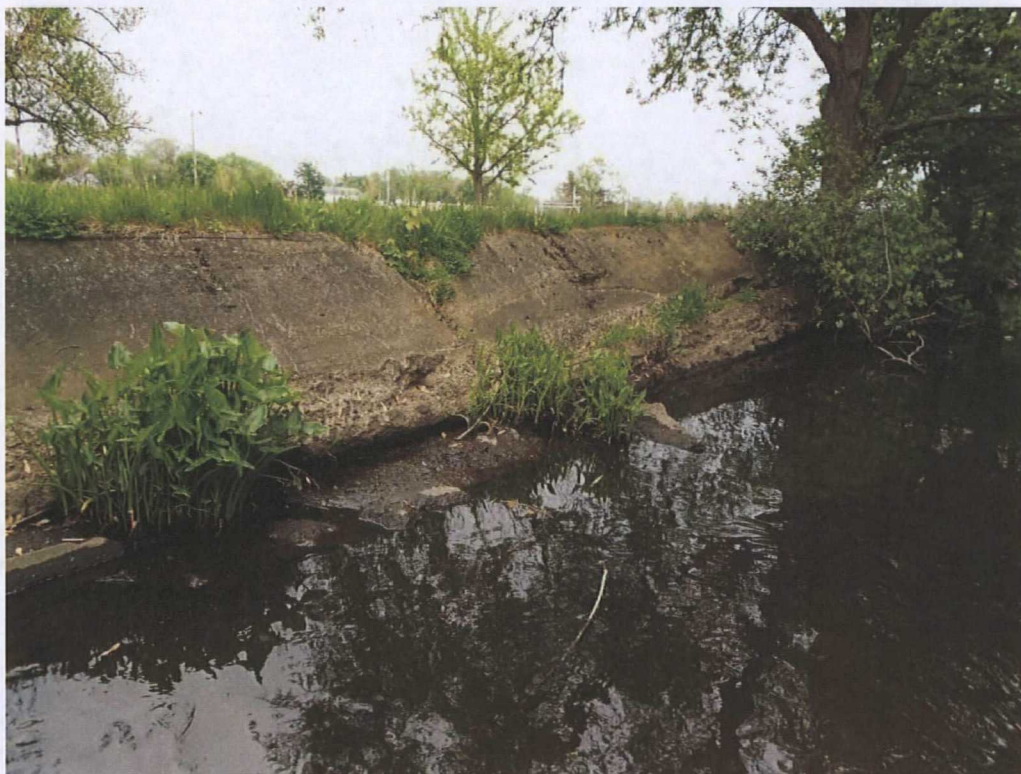
- The concrete is abraded at the waterline with severe cracking and settlement of the slabs.
- There is significant vegetation growth between the slabs and through cracks.
- There is a significant amount of failed rubble in the channel along the toe of the bank.

Cracking and vegetation growth through the structure

- Remove and replace the slabs as required to facilitate cofferdam installation and sediment removal.

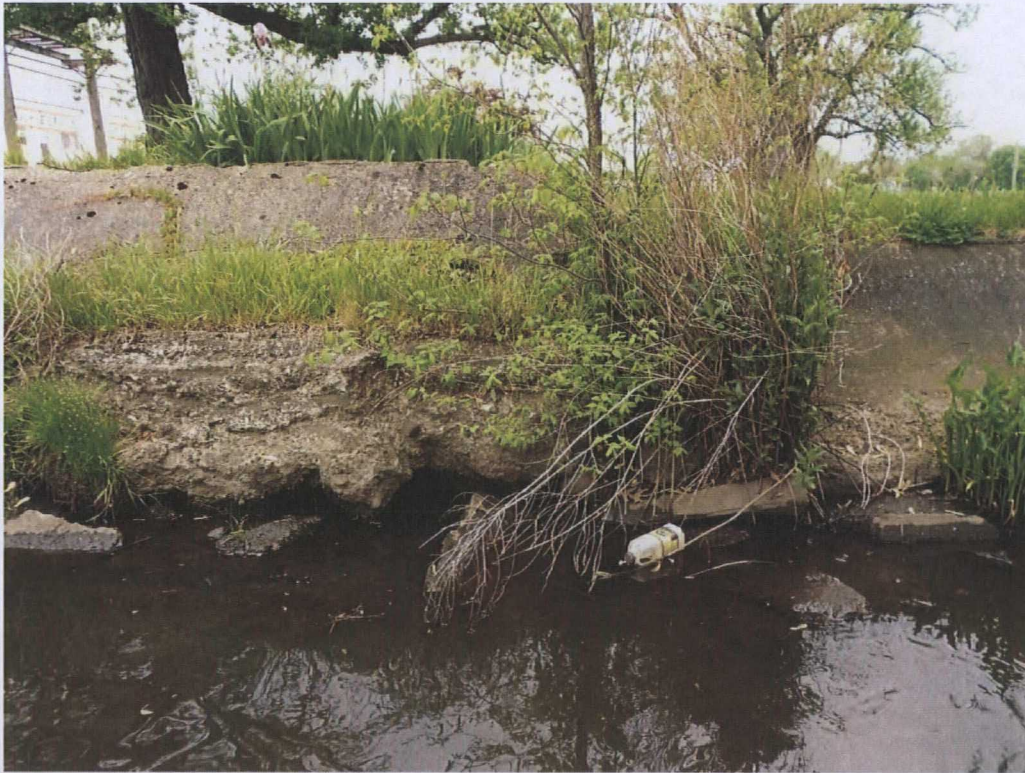
Vegetation growth and abrasion along the waterline

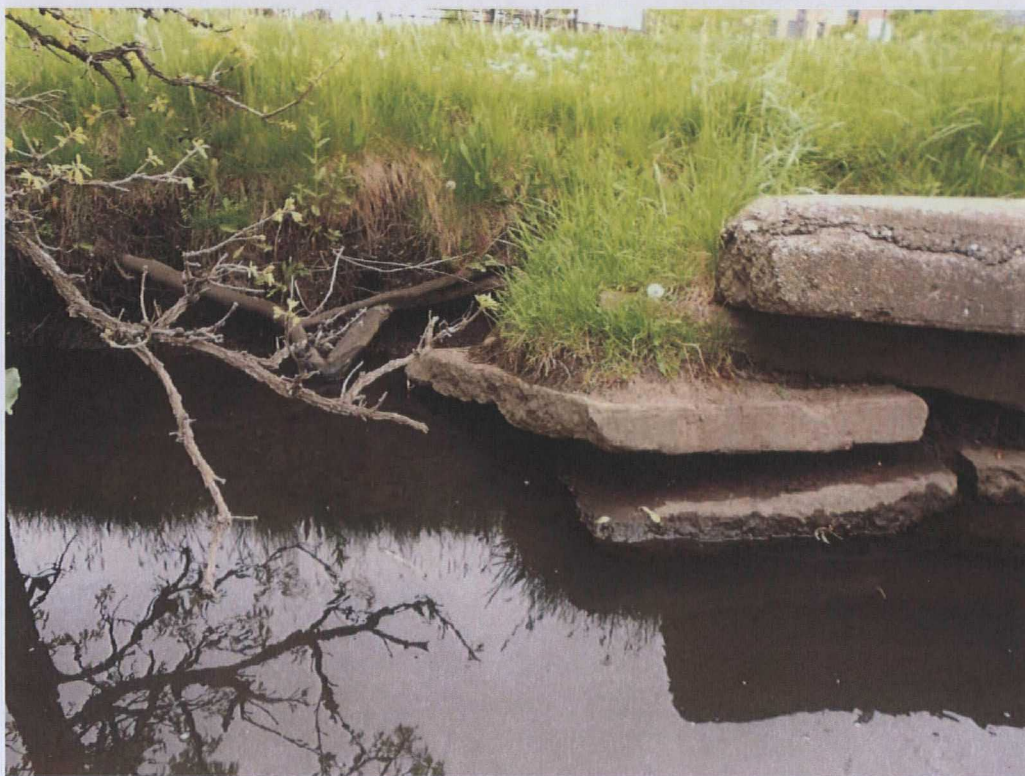
- The 12" concrete storm sewer outlet is severely abraded/spalled exposing the steel reinforcement.
- Slabs have severe cracking and settlement, approximately 2" at the southwest concrete wingwall of the Vine Street bridge.
- There is significant vegetation growth through the wall.
- The south end has severe bank erosion with a sink hole behind the wall.

Failing slabs at the south end of the structure

- Remove and replace the slabs as required to facilitate cofferdam installation and sediment removal or extend the cofferdam around the structure with approximately 4' clearance.
- Protect the storm sewer outlet with a cofferdam to allow for dewatering. Because of its proximity, the cofferdam will likely be part of the cofferdam for the Vine Street bridge.

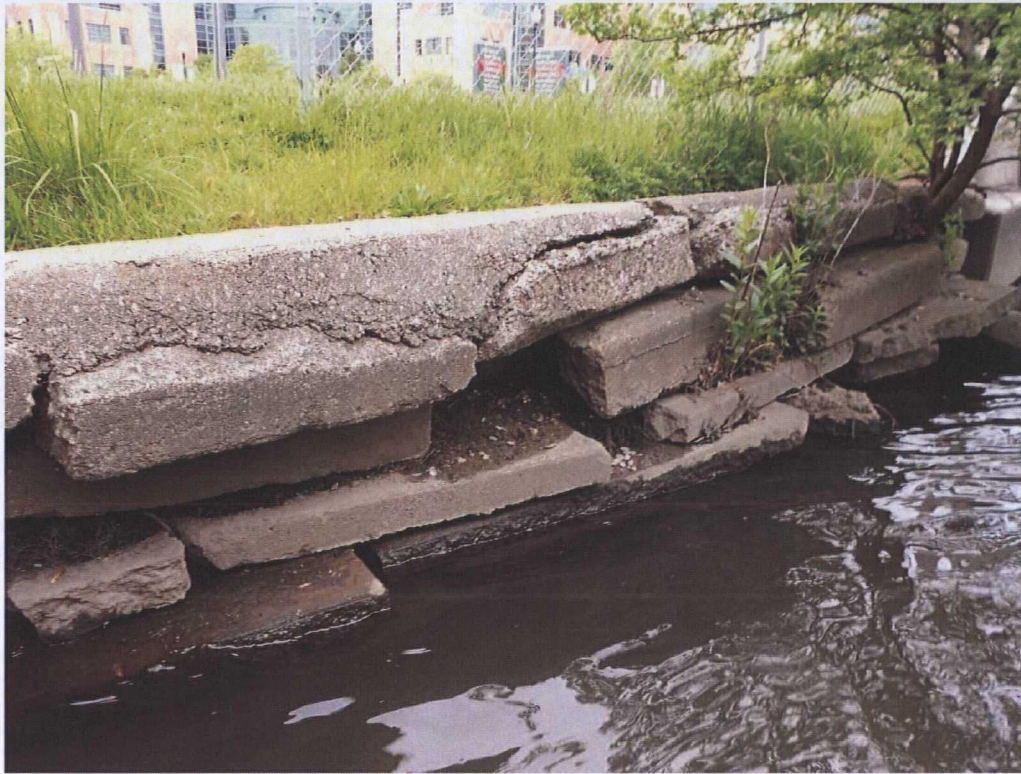
Gaps and vegetation growth in the wall

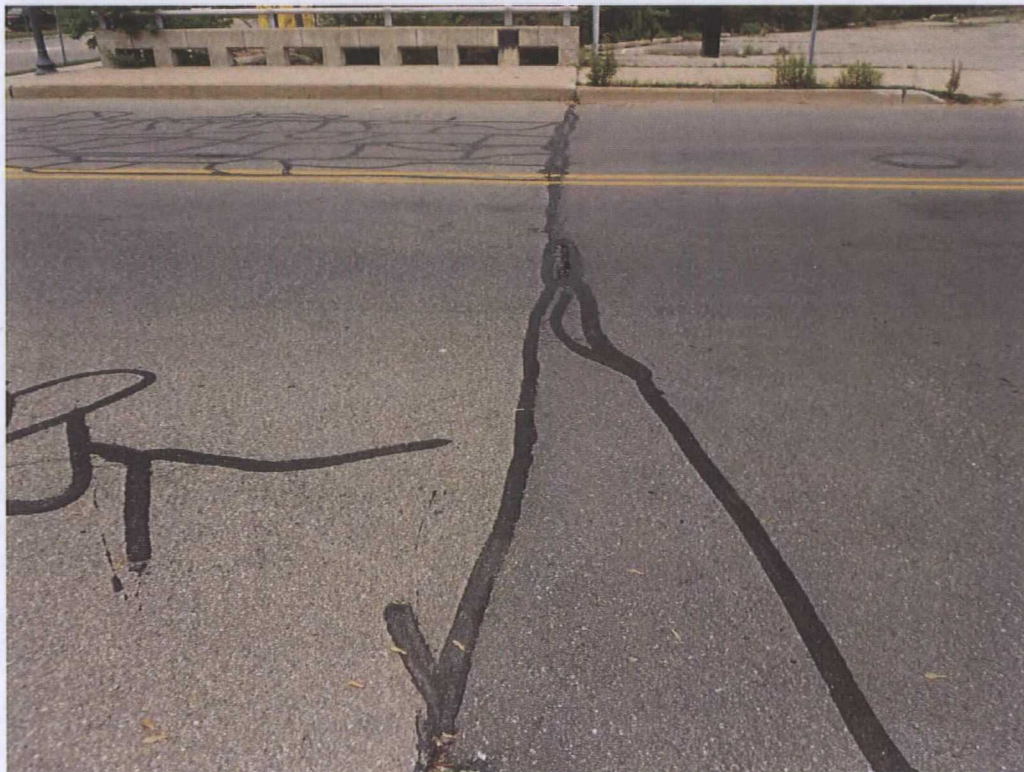
- The asphalt surface has block cracking which is mostly sealed in north lane and south wheelpath. Severe transverse cracking, partly sealed, was noted along the reference lines.

Partially sealed cracking in the asphalt surface

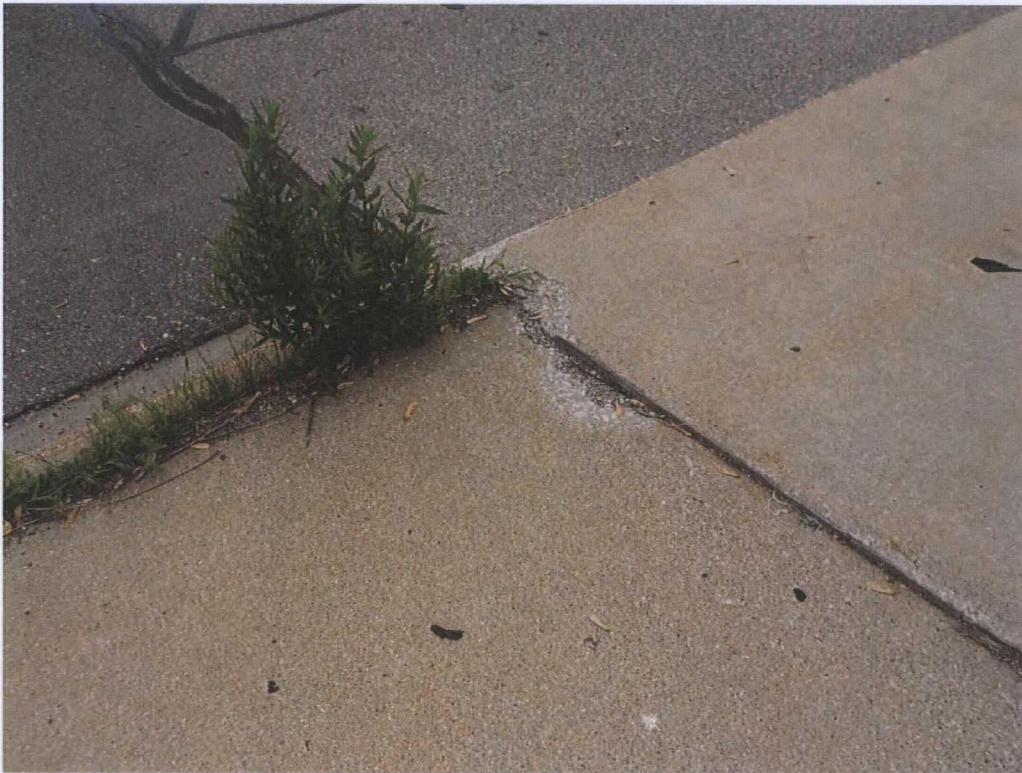
- Minor spalling was noted in the northeast sidewalk and the approach sidewalk has settled approximately 1".
- Severe to critical spalling to steel was noted on a railing post near midspan, north side.

Settlement and spalling of the northeast sidewalk with vegetation growth

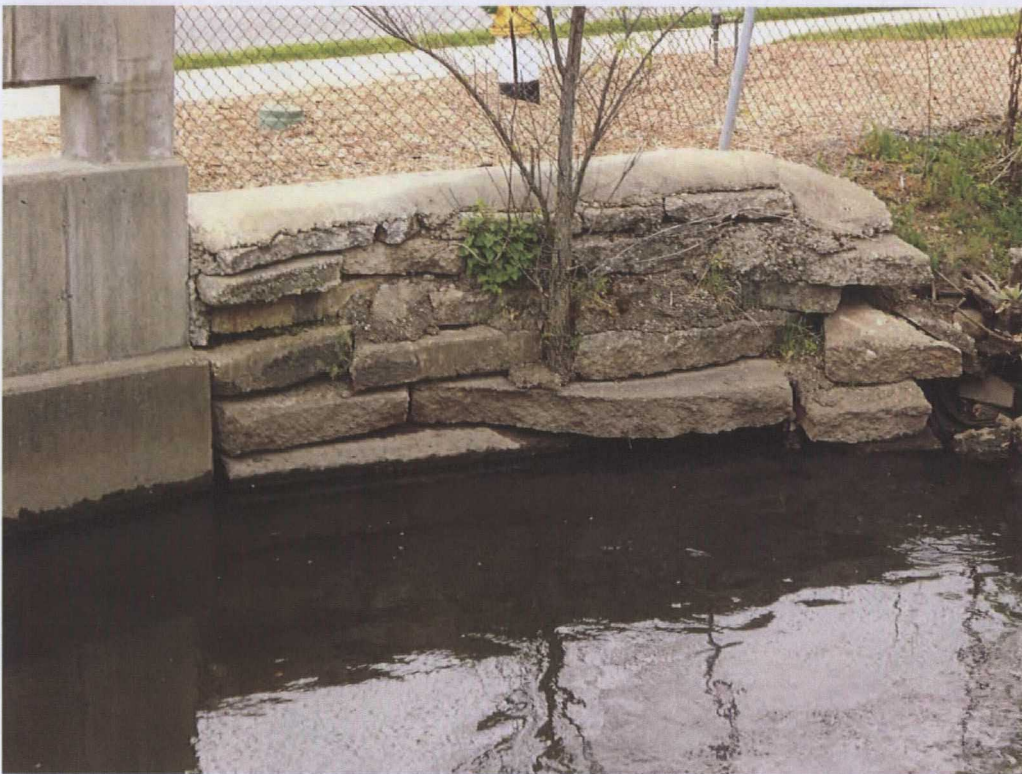
Vegetation growth through the northwest concrete rubble wall

- Because of the bridge's depth of footing and pile support, this structure will not be impacted by the sediment removal operation itself or vibration from sheet pile cofferdam installation. However, the adjacent concrete rubble walls are more susceptible to damage from vibration and likely do not extend below the bottom of the sediment excavation. Therefore, these structures should either be removed and replaced in kind or protected with a sand bag cofferdam. A 4' clearance between cofferdam and face of wall is recommended.

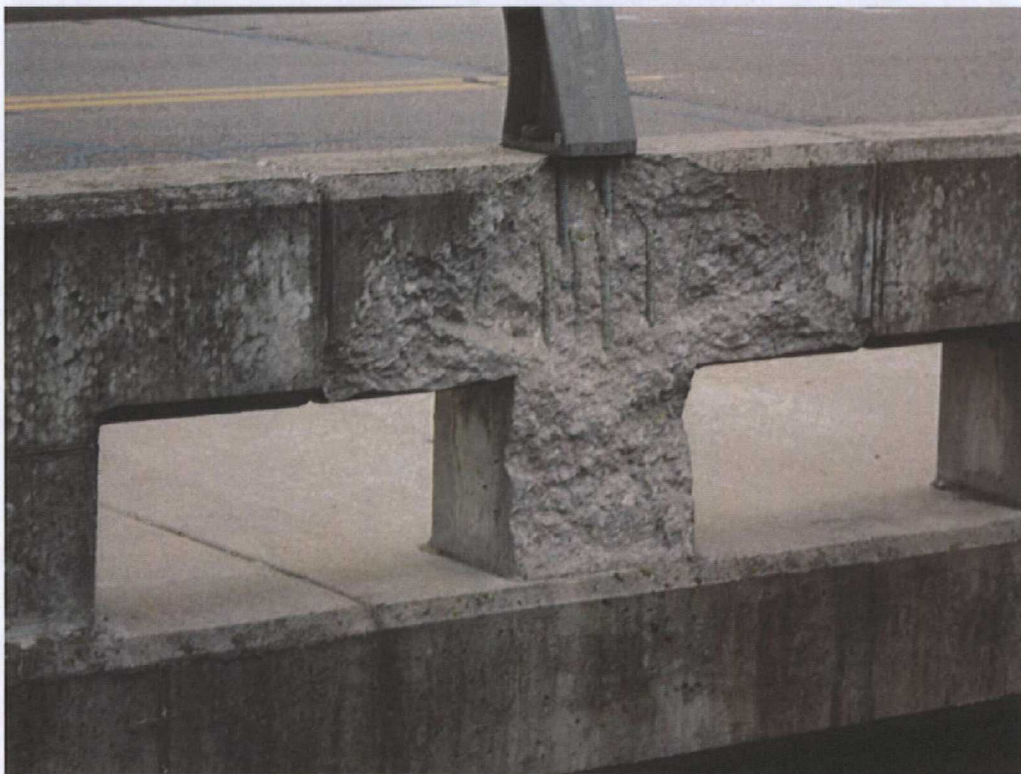
Severe spalling on concrete post of the north railing
